The Problem

Solution

Job Postmortem

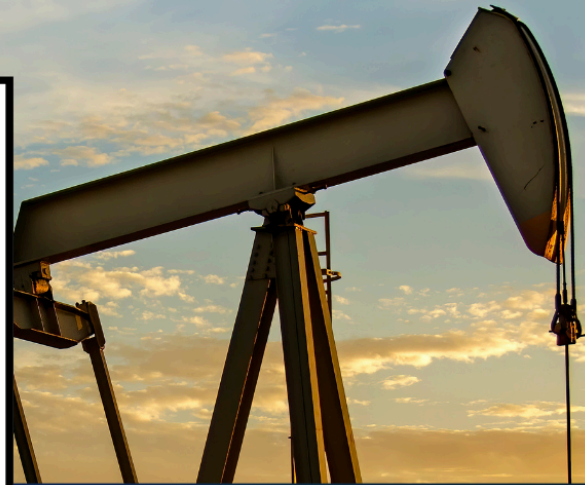
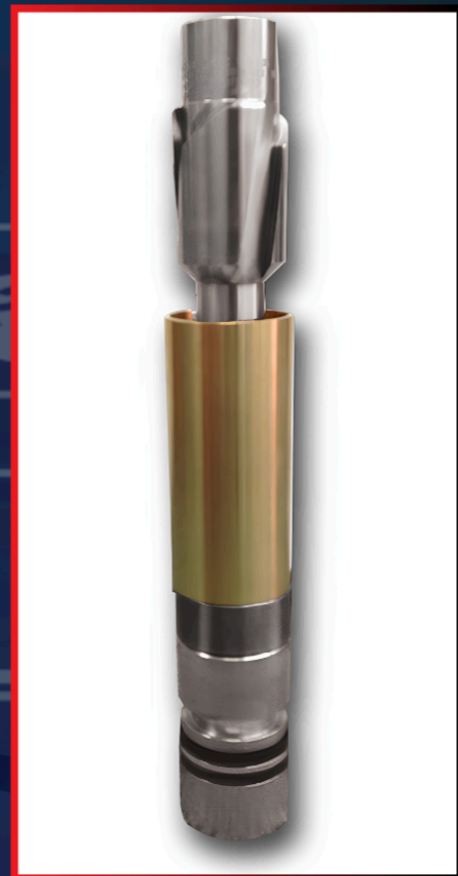
Pump cut out of tubing, solids in pump, plunger was sandcut and barrel was packed off. Severe sand in pump.

In December 23, 2013 an 1 ½ insert pump along with an Eagle Sand Check VRG, Eagle E-Vac, Eagle Dual 92 Plunger, Eagle HighFlow Standing Valve, and Eagle HighFlow Double Valve was installed in Well #47-3.
