# HighFlow Valve

Anadarko Brown 13N-26HZ

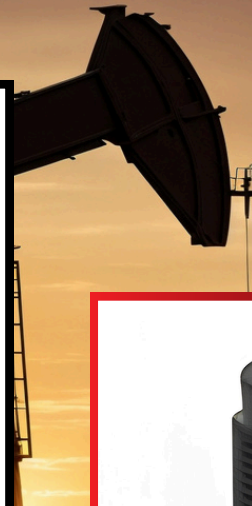
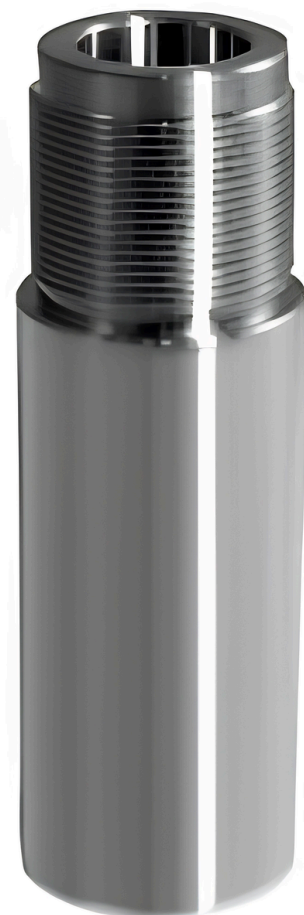
During a pump inspection in July 2021, major wear was identified throughout the pump assembly, including pitted barrels, worn rod guides, scored balls and seats, and an egg-shaped plunger. Despite the overall pump wear, the Eagle HighFlow cages remained in like-new condition and were installed into the rebuilt pump.
